Manhole Inspection Summary

Manhole # S45UU_037MH

Insp Date: **2/7/07 2:35 PM**

Location Address: **2701 TIVOLY AVE**

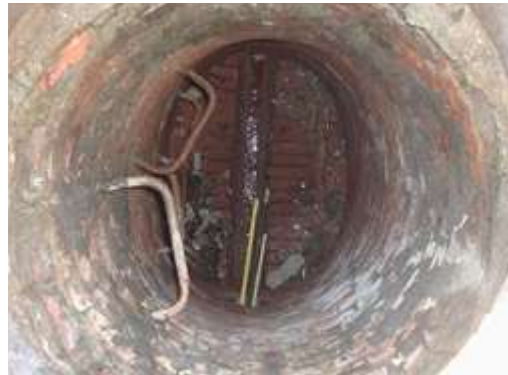
Top View

Corroded steps. Bench debris.

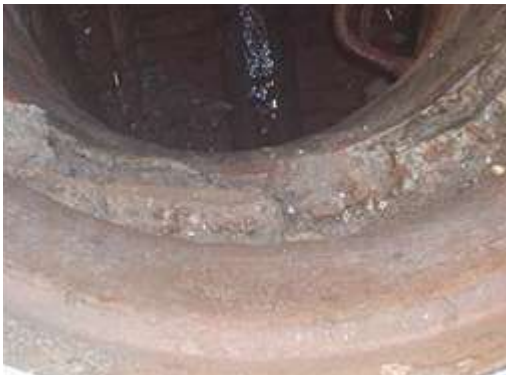
Defect

Frame leaks. Frame offset. Adjustment deterioration and infiltration.

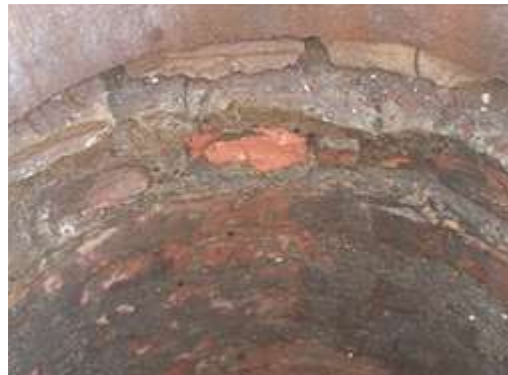
Defect

Frame leaks. Adjustment deterioration and infiltration.

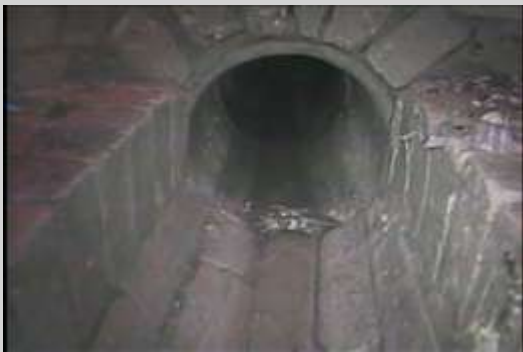
8 in. Circular Gravity Sewer Pipe Out @ 12 O'Clock

Infiltration: **None** Pipe Seal Cond: **Unknown**

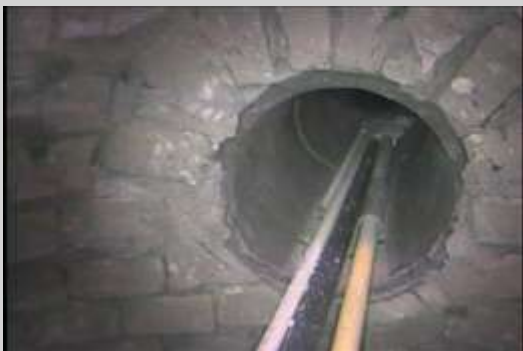
8 in. Circular Gravity Sewer Pipe In @ 6 O'Clock

Infiltration: **Evidence** Pipe Seal Cond: **Unknown**
